# Manhole Inspection Summary

Manhole # S09S\_\_019MH

Insp Date: 11/10/08 12:06 PM

**Location** Address: **3366 Dulany St.** Cross Street: **Bloomfield Ave.**

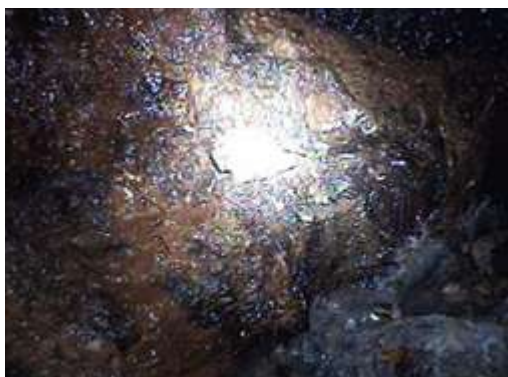
Defect 2

Condition: ☐ Sound ☐ Cracked ☐ Root Intrusion ☒ **Deteriorated** ☐ Leaks ☒ **Debris**

deteriorated bench

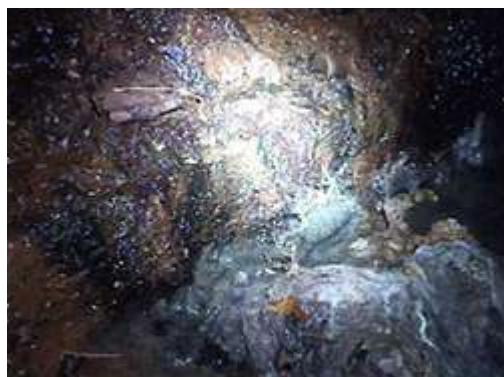
Defect 4

Condition: ☐ Sound ☐ Cracked ☐ Root Intrusion ☐ Deteriorated ☐ Leaks ☒ **Debris**

debris on bench and in channel

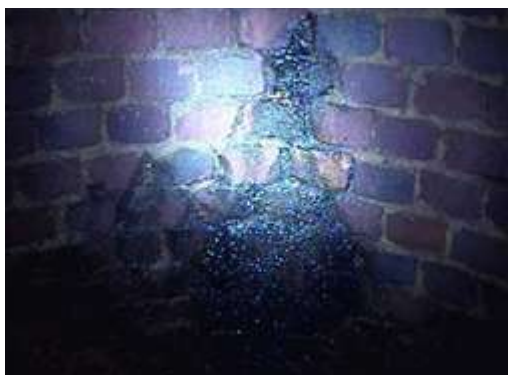
Defect 3

Condition: ☐ Sound ☒ **Cracked** ☐ Root Intrusion ☐ Loose Brick ☐ Deteriorated

Infiltration: ☐ None ☐ Joint ☐ Cracks ☒ **Mortar** ☐ Roots ☒ **Wall**

Barrel cracked, barrel infiltration

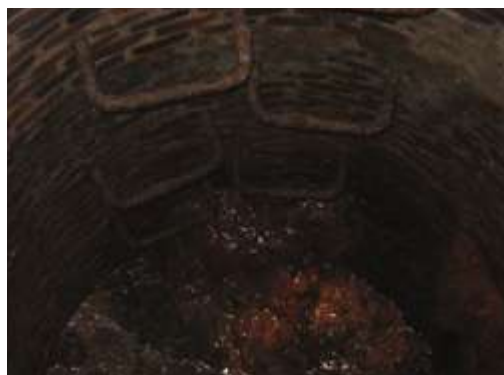
Defect 1

**Steps** Count: **10** Missing: **0** ☒ **Corroded**

corroded steps

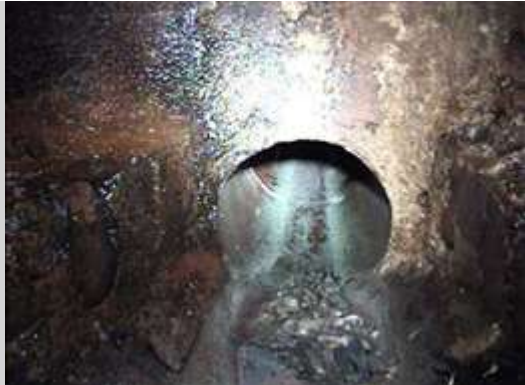
12 O'Clock Outflow

8 in. Circular Gravity Sewer  
Pipe Out @ 12 O'Clock

Pipe Height: **8.4** (in.) Rod and Bar (Angled)  
Pipe Material: **Clay** ☐ Pipe Lined  
Invert Depth: **17.24** (ft.) Flow Characteristics: **Slow**  
Deposits: ☒ None ☐ Mud ☐ Sludge ☐ Debris ☐ Grease  
Silt Depth: **0** (in.) Deposits Extent:  
Infiltration: **Evidence** Pipe Seal Cond: **Sound**

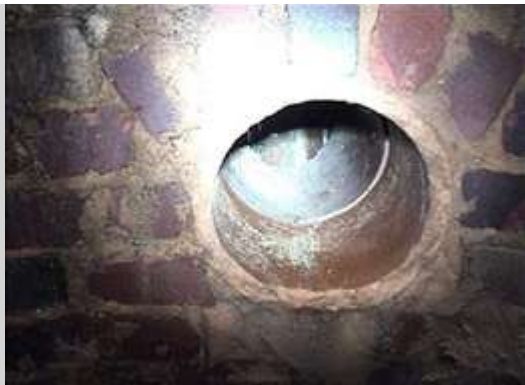
9 O'Clock Inflow

8 in. Circular Gravity Sewer  
Pipe In @ 9 O'Clock

Pipe Height: **8.4** (in.) Rod and Bar (Angled)  
Pipe Material: **Clay** ☐ Pipe Lined  
Invert Depth: **9.22** (ft.) Flow Characteristics: **Slow**  
Deposits: ☒ None ☐ Mud ☐ Sludge ☐ Debris ☐ Grease  
Silt Depth: **0** (in.) Deposits Extent:  
Infiltration: **Evidence** Pipe Seal Cond: **Unknown**

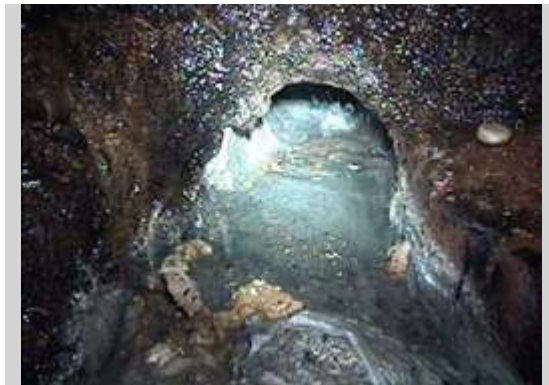
Drop In @ 9 O'Clock

Drop: **Outside** Rod and Bar  
Angled: **Yes** Reading: **15.90** (ft.)  
Inv Depth: **16.90** (ft.)  
Drop Condition: **Open**
